TBF/TBM Avenger

Walk Around Number 25
squadron/signal publications

By Lou Drendel

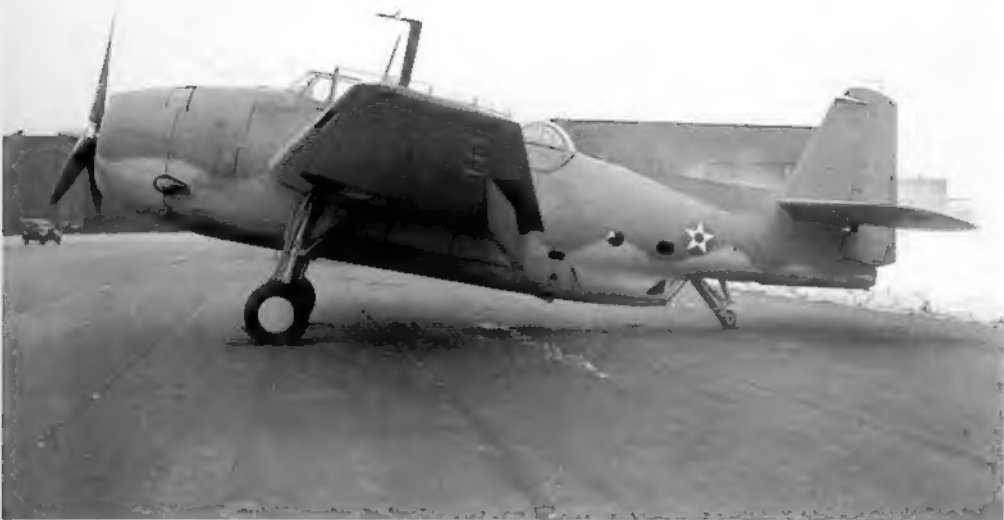
The first production Avenger was this TBF-1 (BuNo 00373), sitting on the Grumman ramp at Bethpage, New York on 9 January 1942. The lowered flaps were hydraulically operated, as were the landing gear and bomb bay doors. Production TBF-1s differed from the XTBF-1 prototype in having the engine moved 11 inches (27.9 cm) forward and the tail surfaces enlarged. These measures corrected the XTBF-1's center of gravity (CG) and directional stability problems. (Grumman)

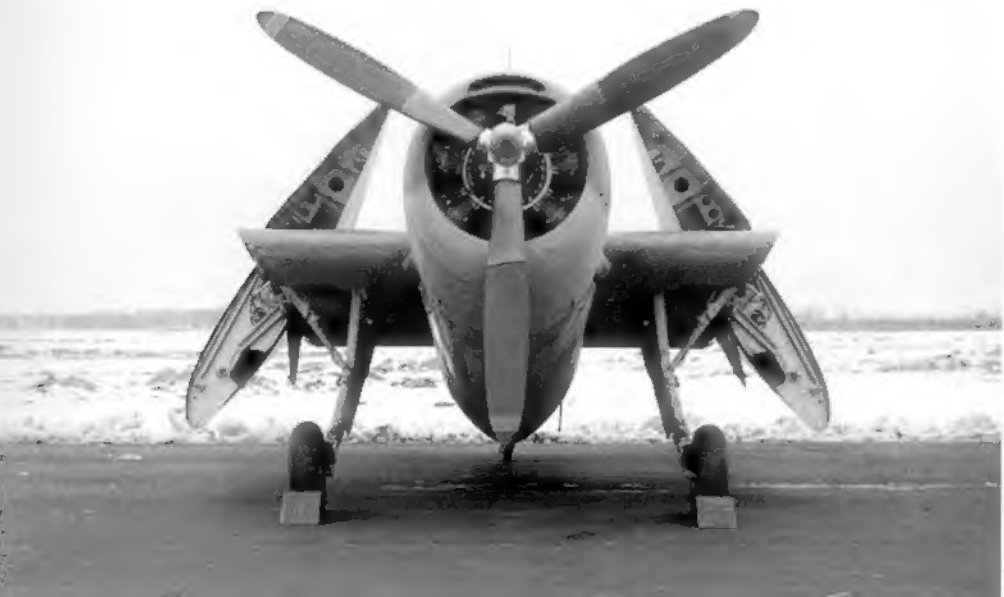
This early production TBF-1 was fitted with the cuffed Curtiss Electric propeller used by Grumman's F4F Wildcat fighter. The unique wing fold mechanism common to many Grumman aircraft was invented by company founder Leroy Grumman using a paper clip stuck in an eraser. This mechanism reduced the Avenger's wing span to 19 feet (5.8 m) without increasing the aircraft's height. (Grumman)

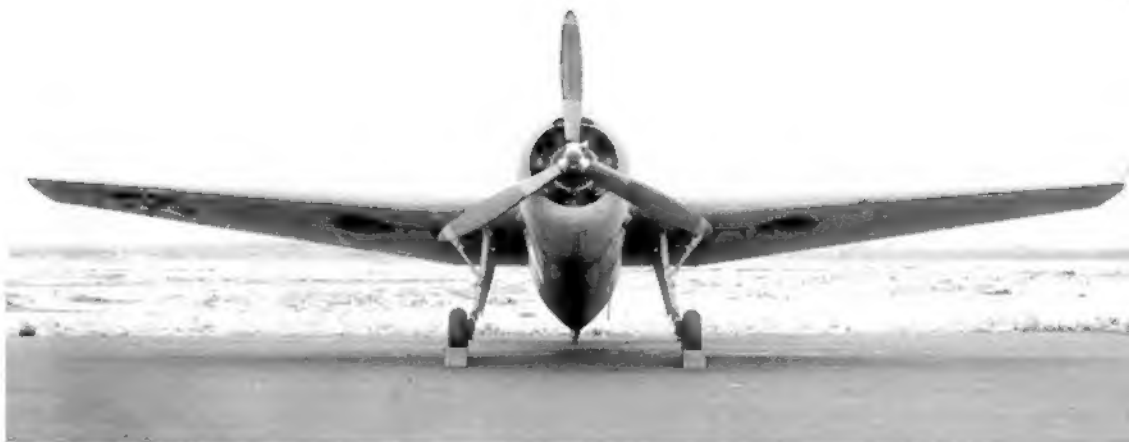
The TBF-1 had a wingspan of 54 feet 2 inches (16.5 m); this wingspan remained the same for all subsequent Avengers. Fixed slots placed in the outboard wing leading edges guided air over the ailerons at high angles of attack. These slots – used in all Avenger models – prevented the aircraft from stalling. The total cost of the two XTBF-1 prototypes, including plans and ground testing, was only \$556,000. (Grumman)

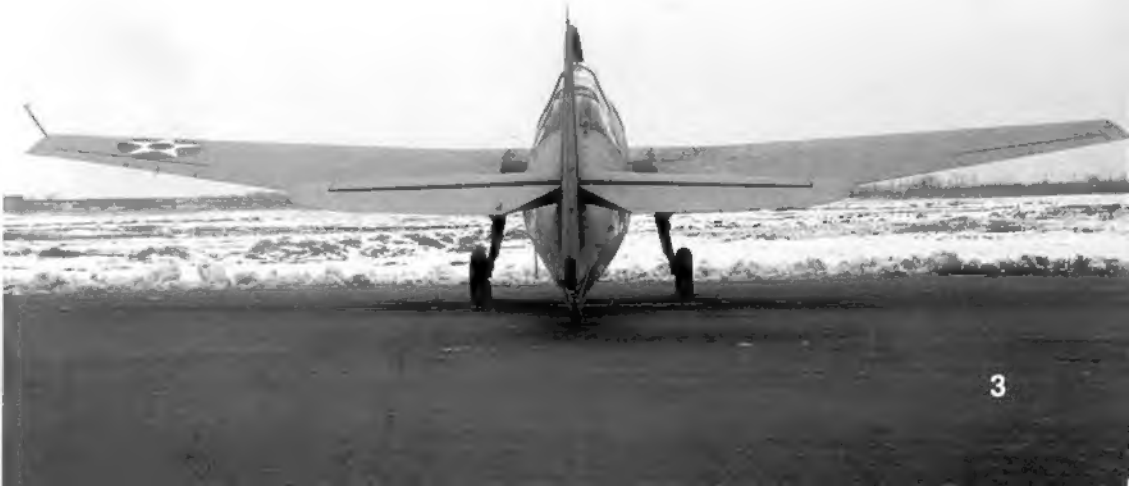
The rear view of the Avenger remained essentially unchanged throughout all versions, beginning with the first production TBF-1. The single .50 caliber (12.7mm) turret mounted Colt-Browning M2 machine gun was offset to the right of the aircraft's centerline. US Navy aircraft displayed the national insignia on the upper left and lower right wing surfaces from 26 February 1941 until 5 January 1942. (Grumman)

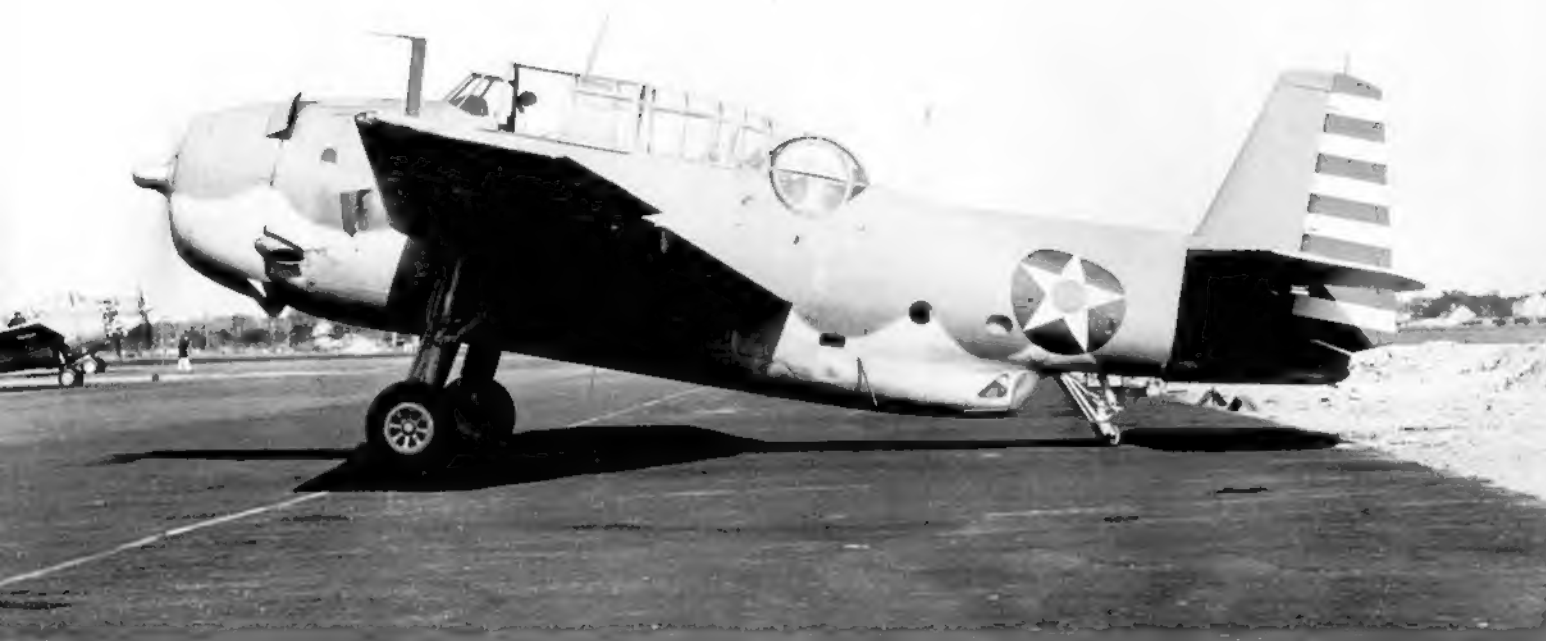
A primary identifying characteristic of the TBF-1 was the shortened cowl flaps. The aircraft was fitted with the cowl flap on the upper cowling surfaces to allow heat to escape from the engine area. The oil cooler air flap was mounted aft of the cowl and ahead of the wing leading edge. These flaps were usually open when the aircraft was warming up its engine. This early Avenger was armed and had the additional glass fairing forward of the turret. This glass fairing was deleted from the TBF-1C and later Avenger models. The 13 stripes on the rudder – seven red, six white – were required on US Navy aircraft from 23 December 1941 until 6 May 1942. The stripes and the red portions of the national insignia were deleted on 6 May, to prevent US aircraft from being confused with Japanese aircraft, which used the red *Hinomaru* (rising sun) insignia. (Grumman)

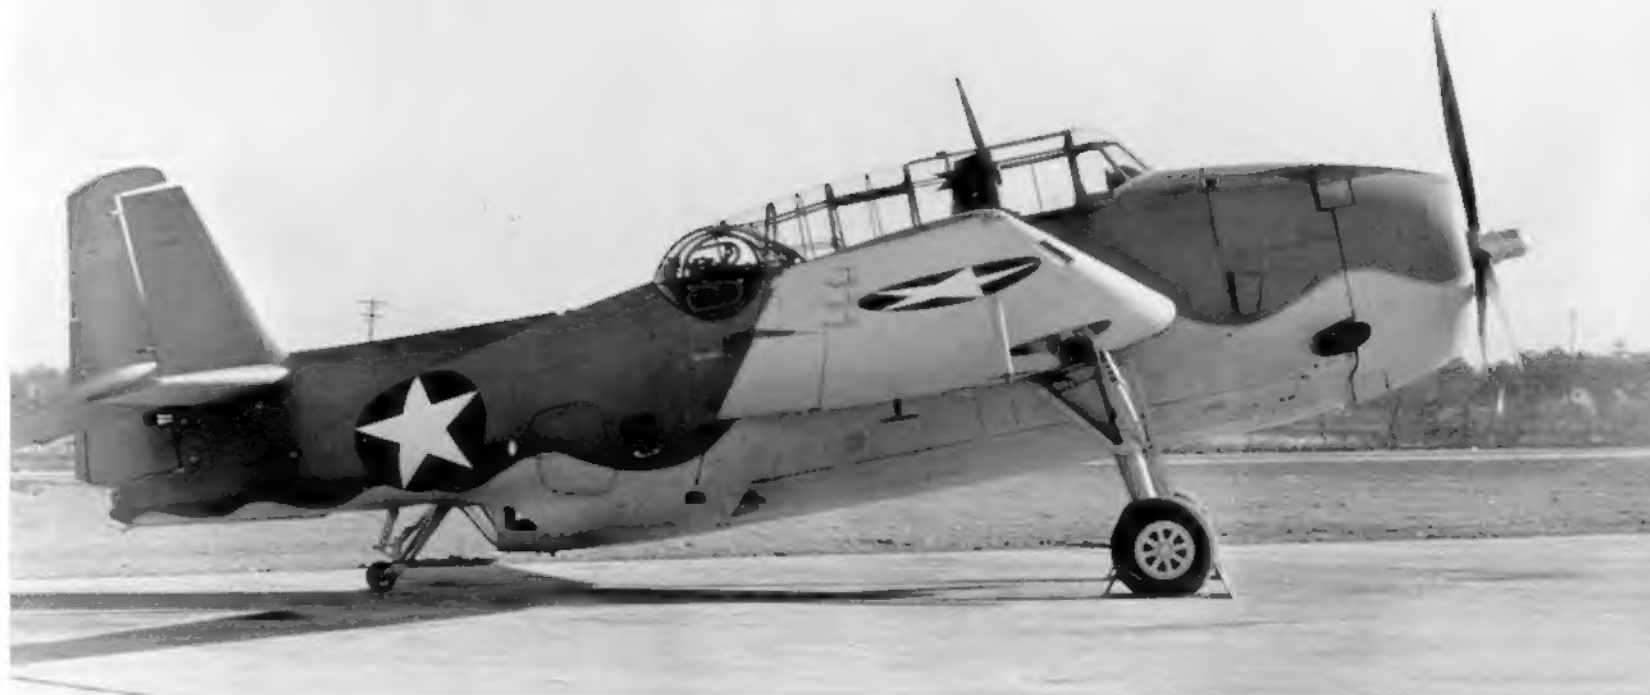
A TBF-1 (22-C-8, BuNo 55051) flies low over the water on a practice mission during the first half of 1943. This Avenger was assigned to Composite Squadron 22 (VC-22) aboard the light carrier USS INDEPENDENCE (CVL-22). The three-tone color scheme of Sea Blue, Intermediate Blue, and White was applied to this aircraft, which has black fuselage codes. These codes were usually reduced to the individual aircraft numbers when the Squadron

entered the combat zone, to deny unit information to enemy intelligence. The Grumman 150SE rear turret was turned fully to the starboard beam firing position. The TBF-1 was distinguished from later Avenger models by the nose-mounted .30 caliber (7.62mm) Colt-Browning M2 machine gun, its short cowl flaps, and the open oil cooler door just ahead of the wing root. (US Navy via Warren Bodie)

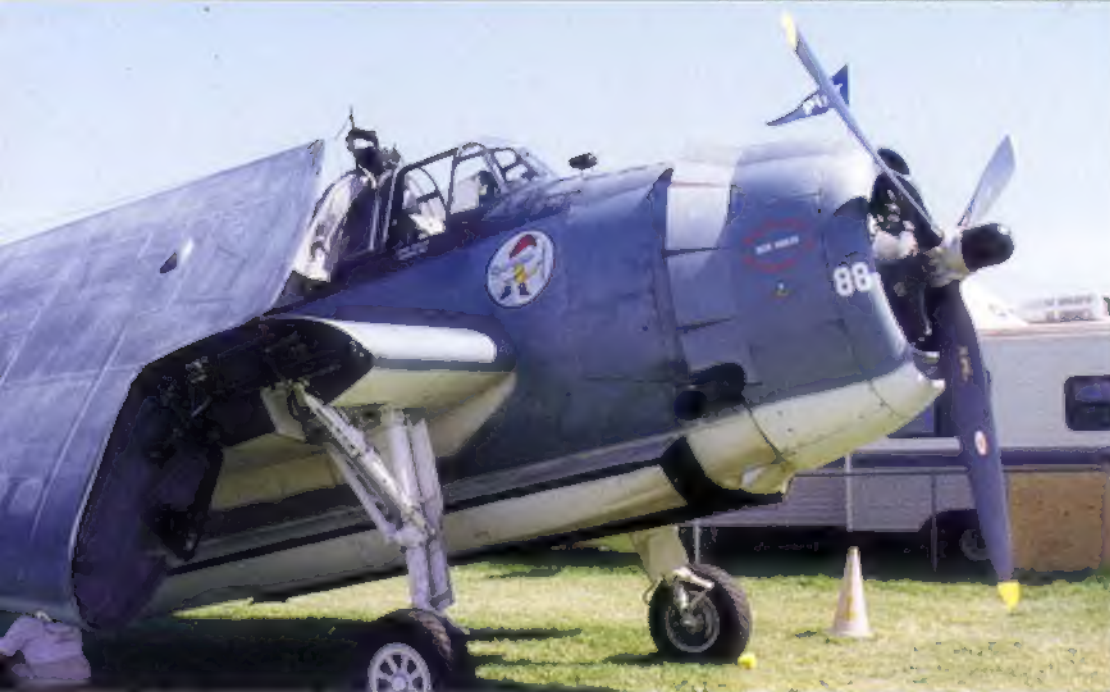
The wings were folded back on this restored TBM-3, which participated in the EAA Fly-In at Oshkosh in 1997. The TBM-3 series was identified by air intakes located at the top and bottom of the cowl; the earlier TBF/TBM-1 only had the upper cowl intake. The later model's full-surround cowl flaps provided additional air cooling of the more powerful 1900 hp Wright R-2600-20 radial engine. (Lou Drendel)

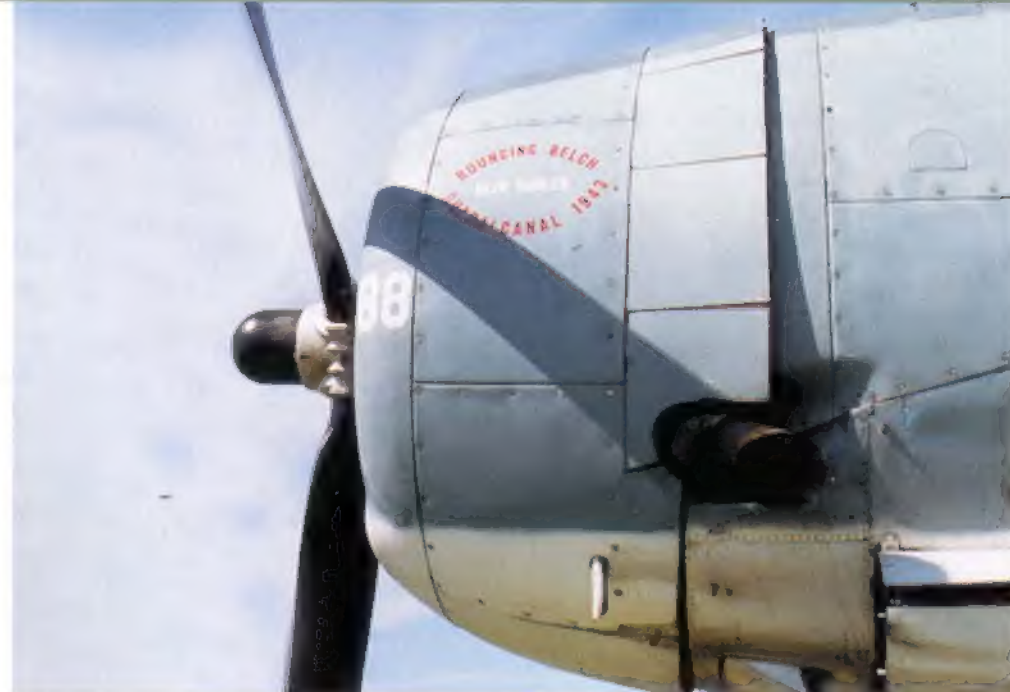
All Avenger models were fitted with the three-bladed, all-metal Hamilton Standard Hydromatic propeller, which measured 13 feet 1 inch (4 m) in diameter. The pilot could hydraulically adjust the propeller pitch from 22° to 49° for improved engine efficiency. The propeller reduction gearbox was placed behind the hub and the propeller governor was mounted on top of this gearbox. (Lou Drendel)

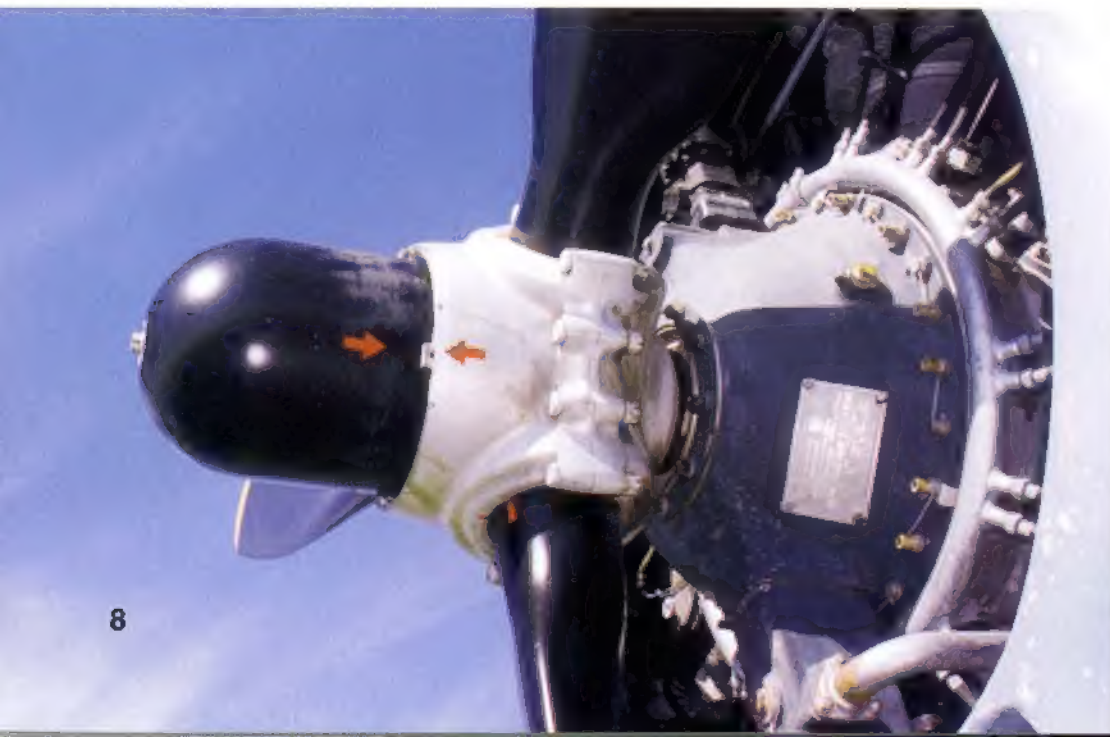
The bulge on the TBM-3's lower front cowling accommodated the oil cooler intake. The tube protruding from the lower cowl was the oil overflow pan drain, from which excess engine oil was vented from the aircraft. This restored Avenger's cowling was marked BOUNCING BELCH BEER HAULER GUADALCANAL 1943. (Lou Drendel)

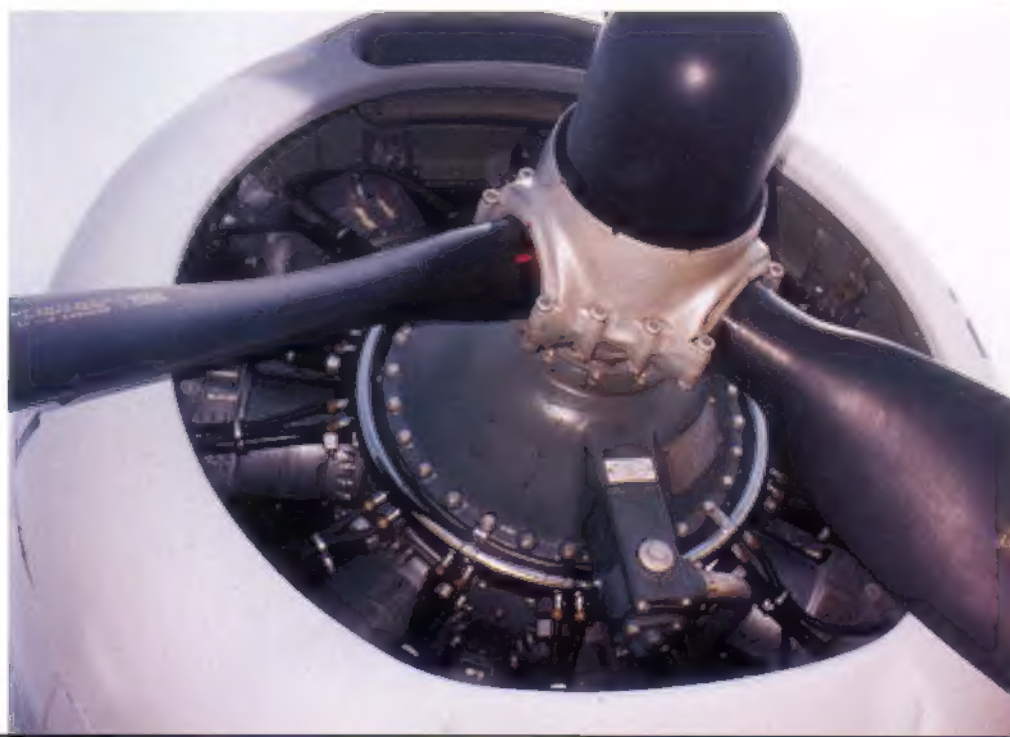
This Avenger – and all other production examples – was equipped with the Hamilton Standard constant speed propeller, while the two Avenger prototypes used Curtiss Electric propellers. The spinner dome was filled with engine oil to operate the propeller pitch mechanism. The TBM-3's R-2600-20 engines had 14 cylinders in two rows. This TBM-3's propeller blades and spinner dome were painted black, while the hub was left in natural metal. (Lou Drendel)

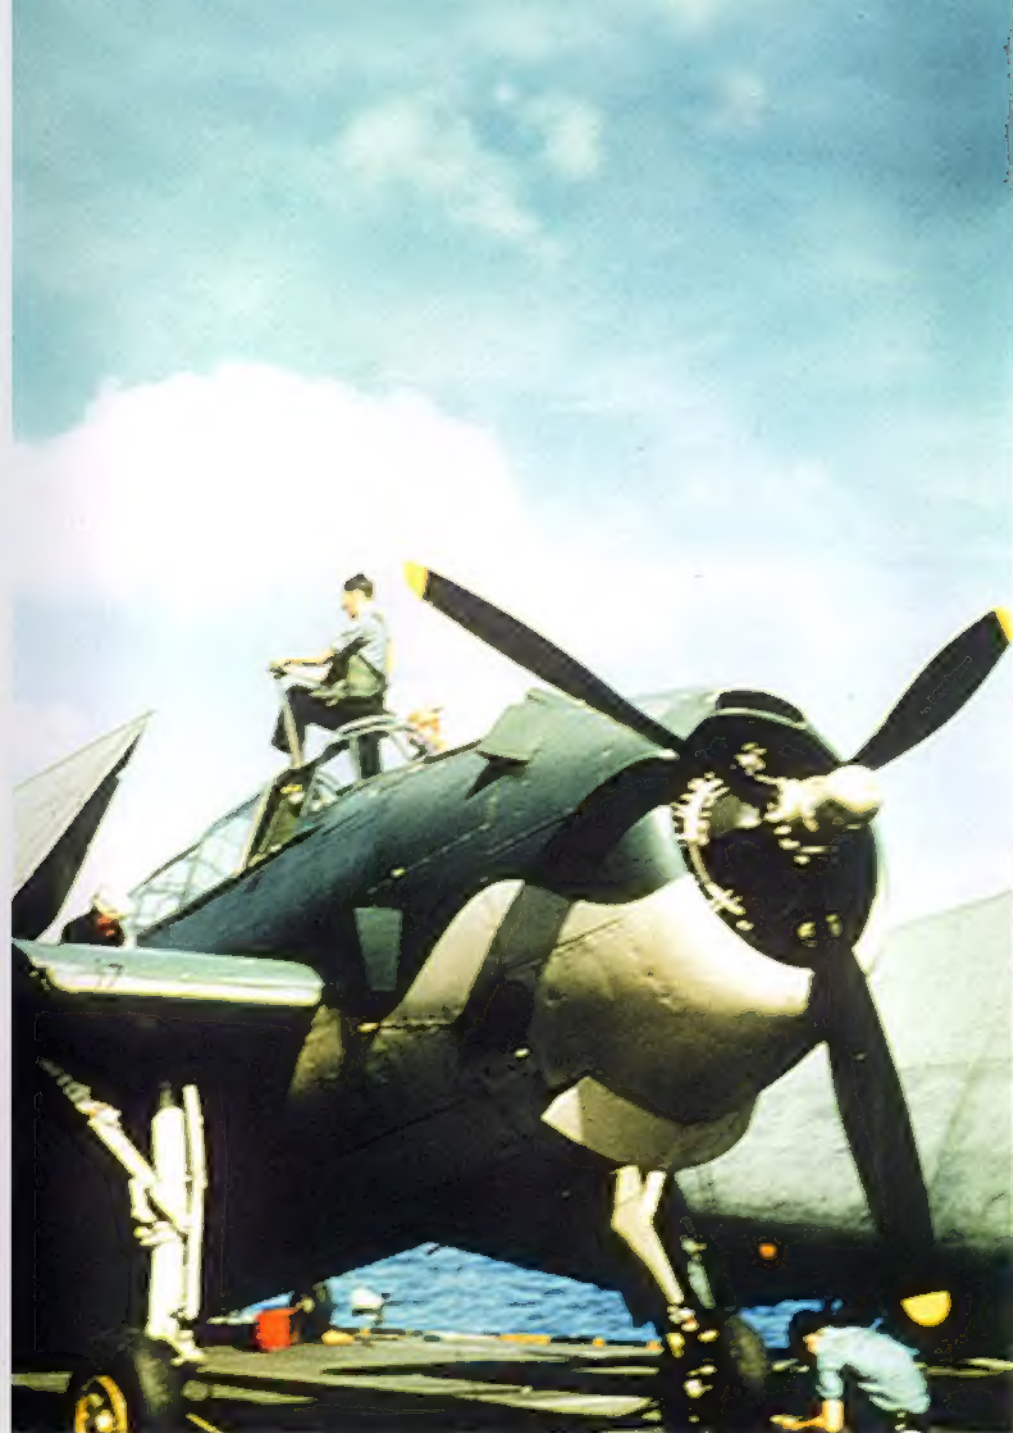
Deployed aboard a carrier during 1942, this TBF-1 has this model's standard cooler intake fitted to the upper cowling. The Avenger's first combat was at the Battle of Midway on 4 June 1942, when six land-based TBF-1s of VT-8 attacked the Japanese fleet. Japanese fighters shot down five of the six Avengers and the only survivor crash-landed on Midway with the turret gunner killed and both the pilot and bombardier/ventral gunner wounded. (US Navy via Warren Bodie)

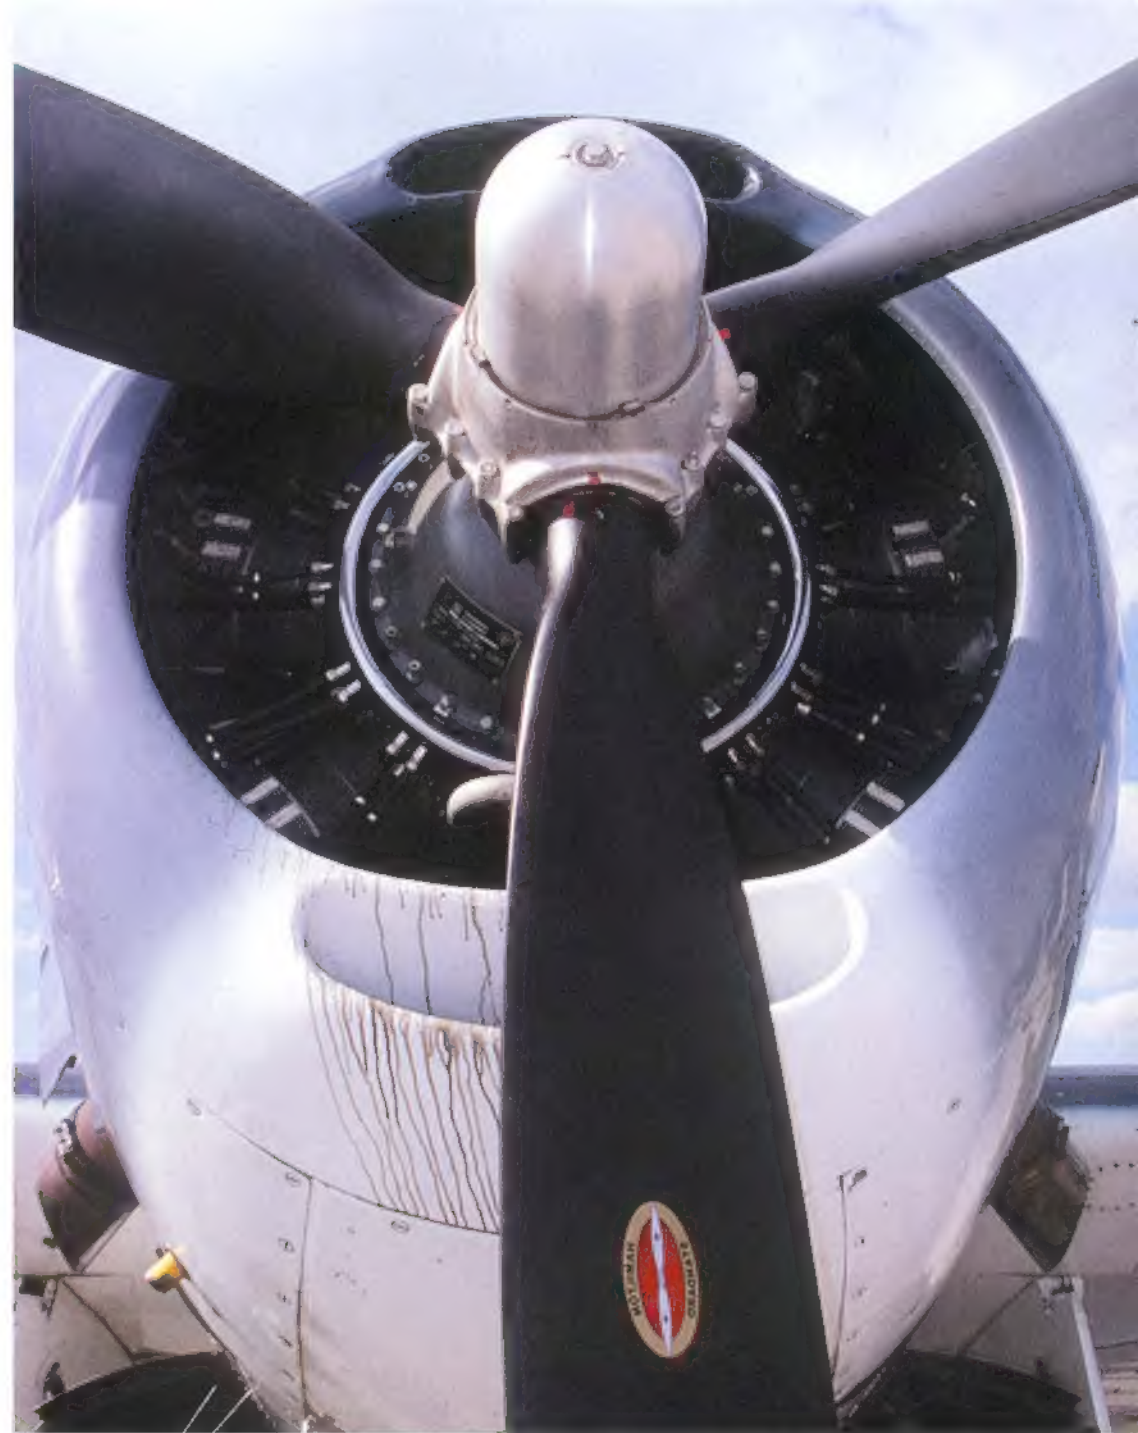
The nose of this TBM-3 differed from the earlier TBF-1 in adding a lower cooler intake, which was slightly wider than the upper intake. The upper cooler intake also fed air into the R-2600-20 engine's twin carburetors, which sent air and fuel into the engine cylinders for combustion. The silver ring around the propeller reduction gearbox housed the ignition wires. These wires were connected to a spark plug fitted to each of the engine's 14 cylinders. (Lou Drendel)

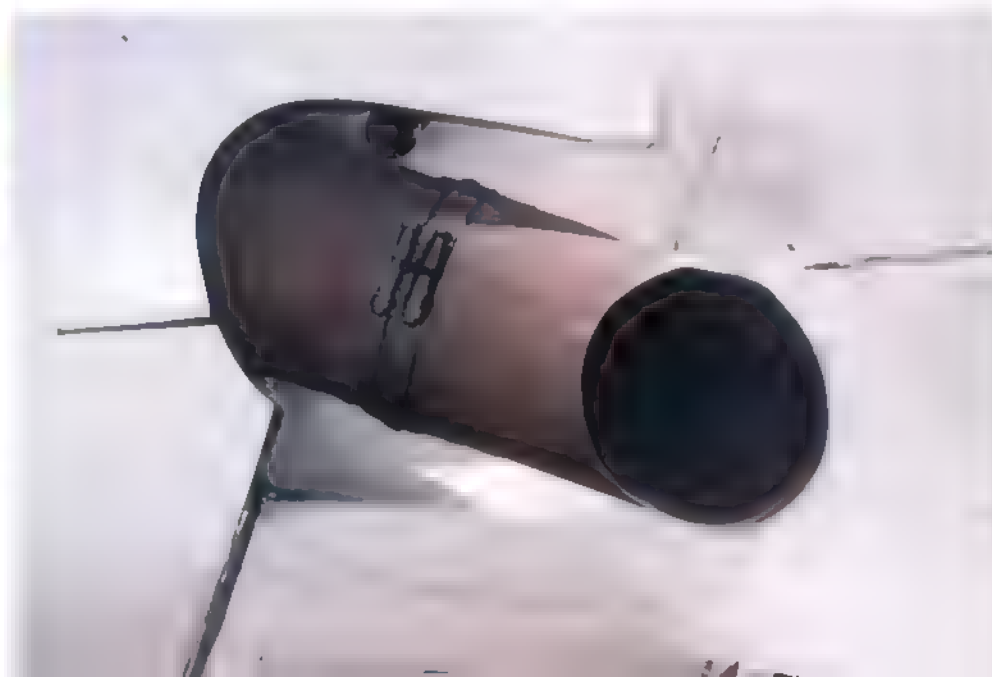
The port exhaust stack on the TBM-3 vented out exhaust gases from the seven left cylinders of the R-2600-20 engine. The starboard exhaust stack – through which fumes from the seven right cylinders were removed from the aircraft – was identical in appearance. Hot exhaust gases darkened the metal exhaust stack after only a short period of use. The base of the exhaust stack was fastened to the exhaust collector ring – which brought the exhaust gases from the engine's cylinders – by a clamp with two bolts. (Lou Drendel)

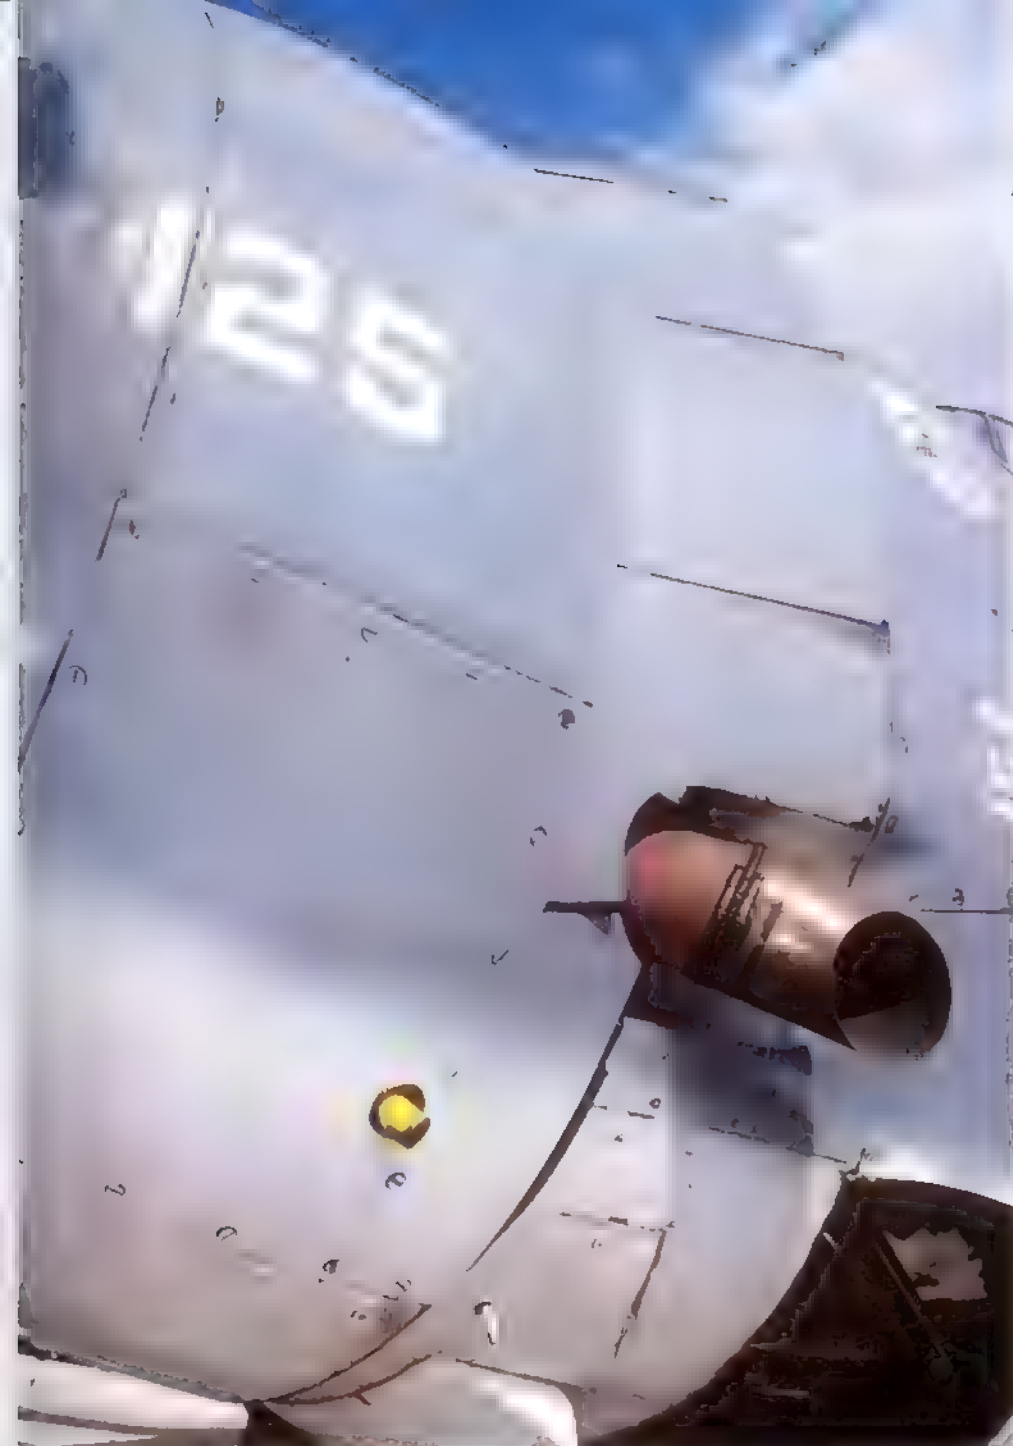
The cowl flaps were extended on this idle TBM-3's engine cowling. The cowl flaps were fully opened during engine warm up and ground operation and partially open for climbing to cruise altitude. These flaps were usually closed for level flight and cruising climbs under normal temperature conditions. The oil overflow pan drain was placed on the lower port cowling area. (Lou Drendel)

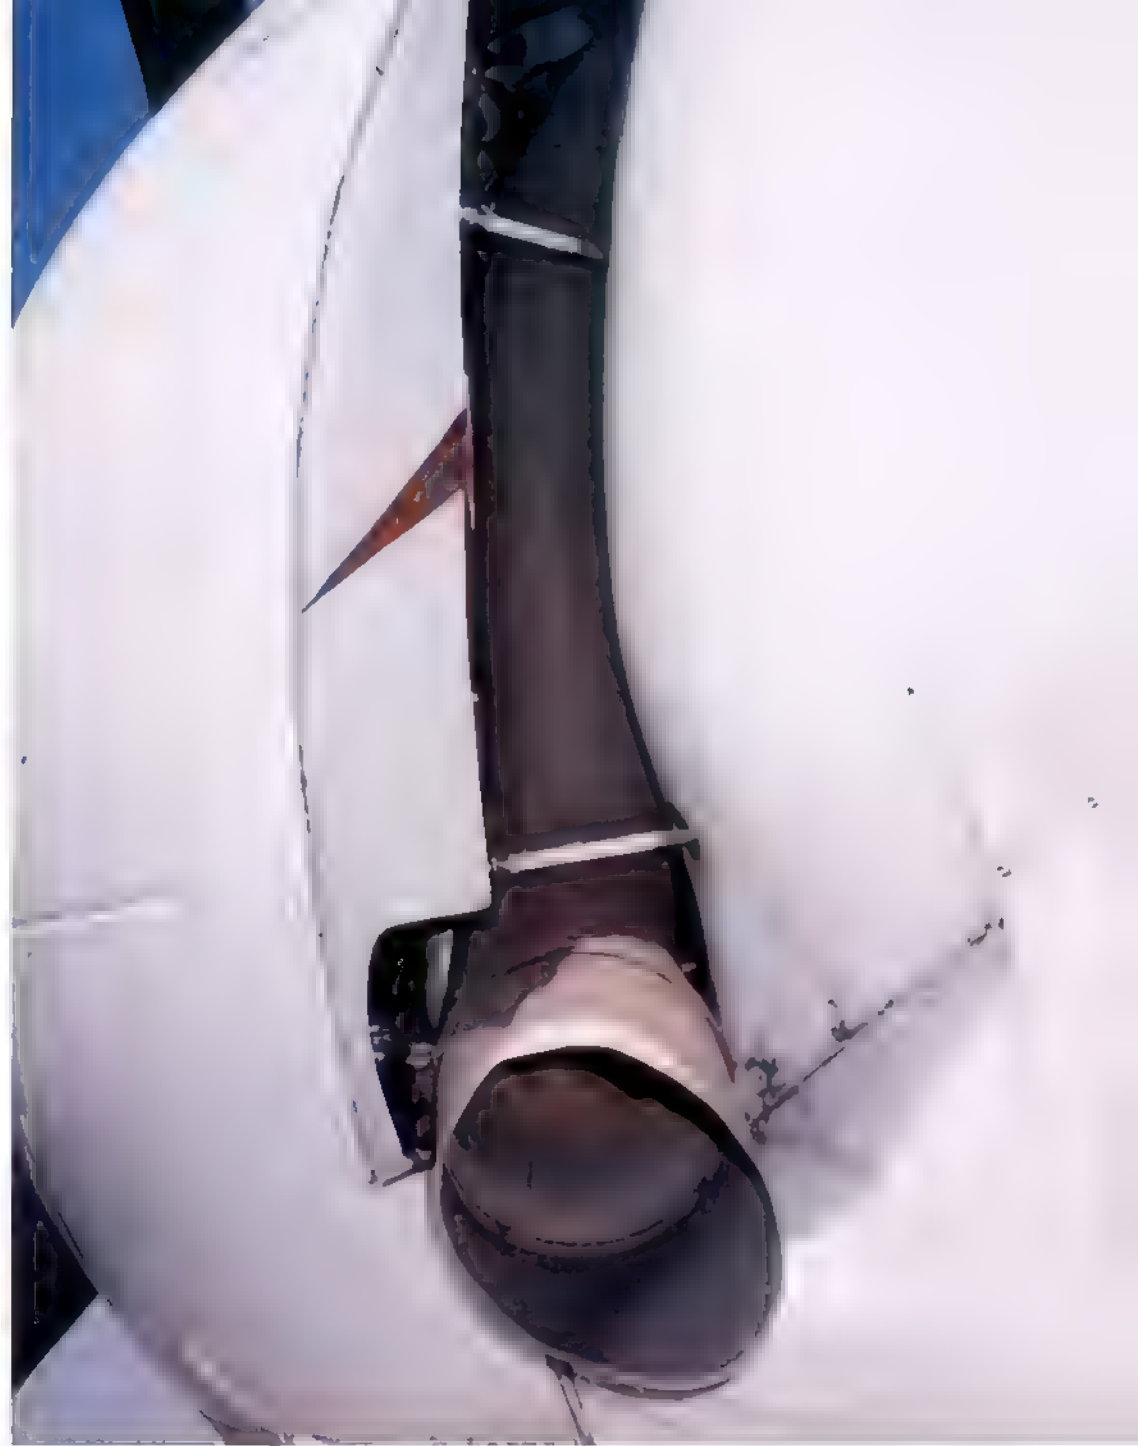
Cowl flap actuating rods adjusted the position of these flaps based on input from the cockpit. The pilot could set the cowl flaps in either the open, closed, or neutral (intermediate) positions. The earlier TBF/TBM-1 had only one cowl flap per cowling side, as opposed to the TBM-3's four flaps per side. The exhaust collector ring fed engine exhausts to the exhaust stack. (Lou Drendel)

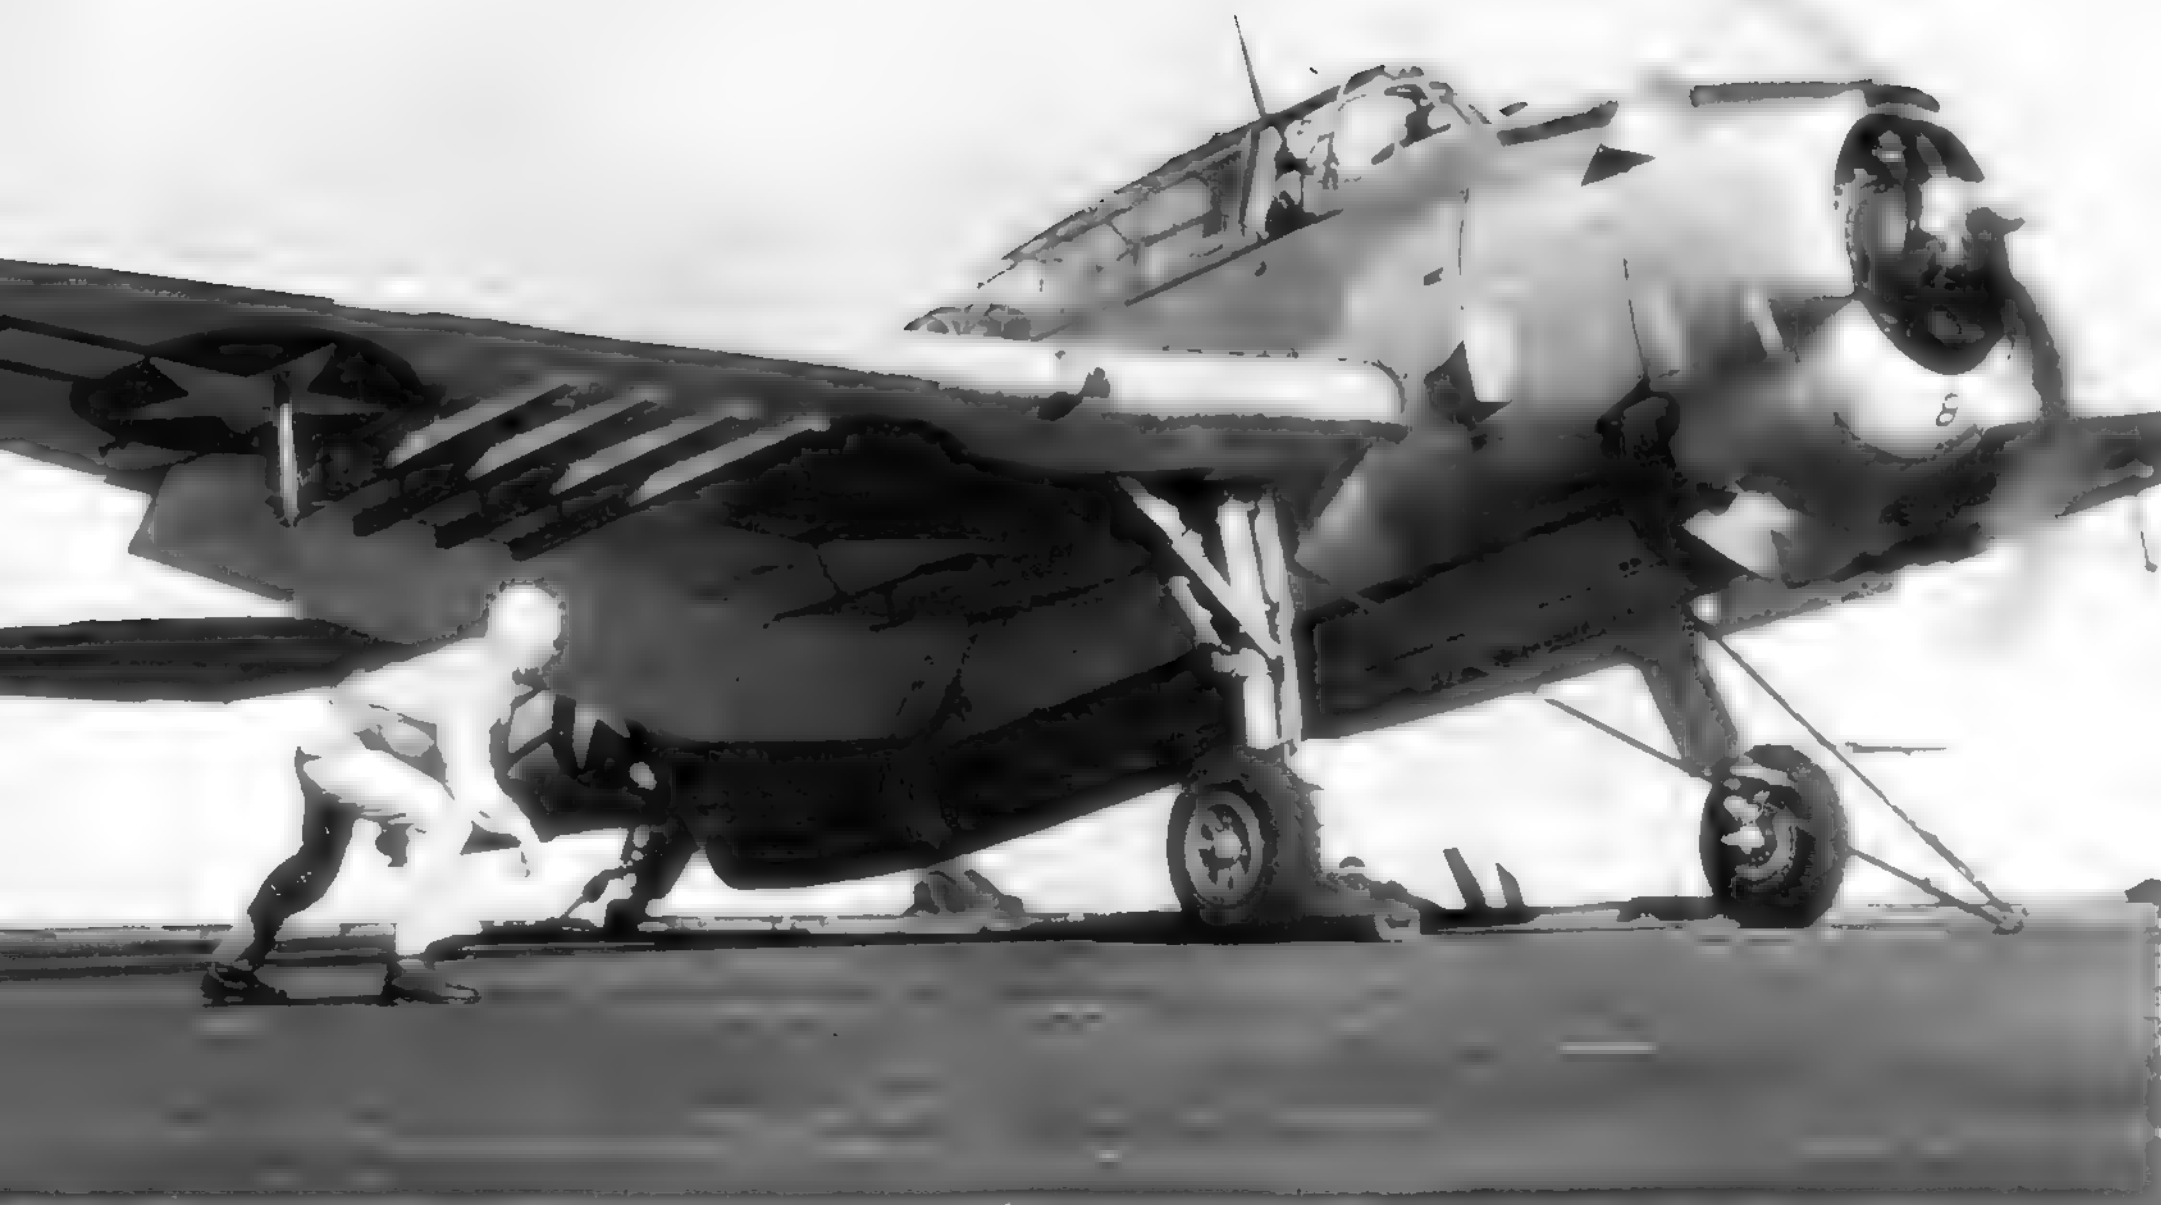
A TBF-1C is prepared for launching from an aircraft carrier in mid-1944. A cable bridle from the catapult shuttle was fitted to hooks fixed to the Avenger's port and starboard main landing gear door to pull the aircraft with the shuttle. The bridle dropped off the aircraft into the sea after the aircraft was launched. This Avenger was armed with a .50 cal-

iber (12.7mm) machine gun in each wing and was fitted with four 70 inch (177.8 cm) Mark 4 rocket launch rails under each wing. The upper cowling flap and the lower oil cooler flap were opened for the TBF's launch. An AN-N6 gun camera is fitted ahead of the windshield to record the results of the TBF-1C's gun firing. (Associated Press from US Navy)

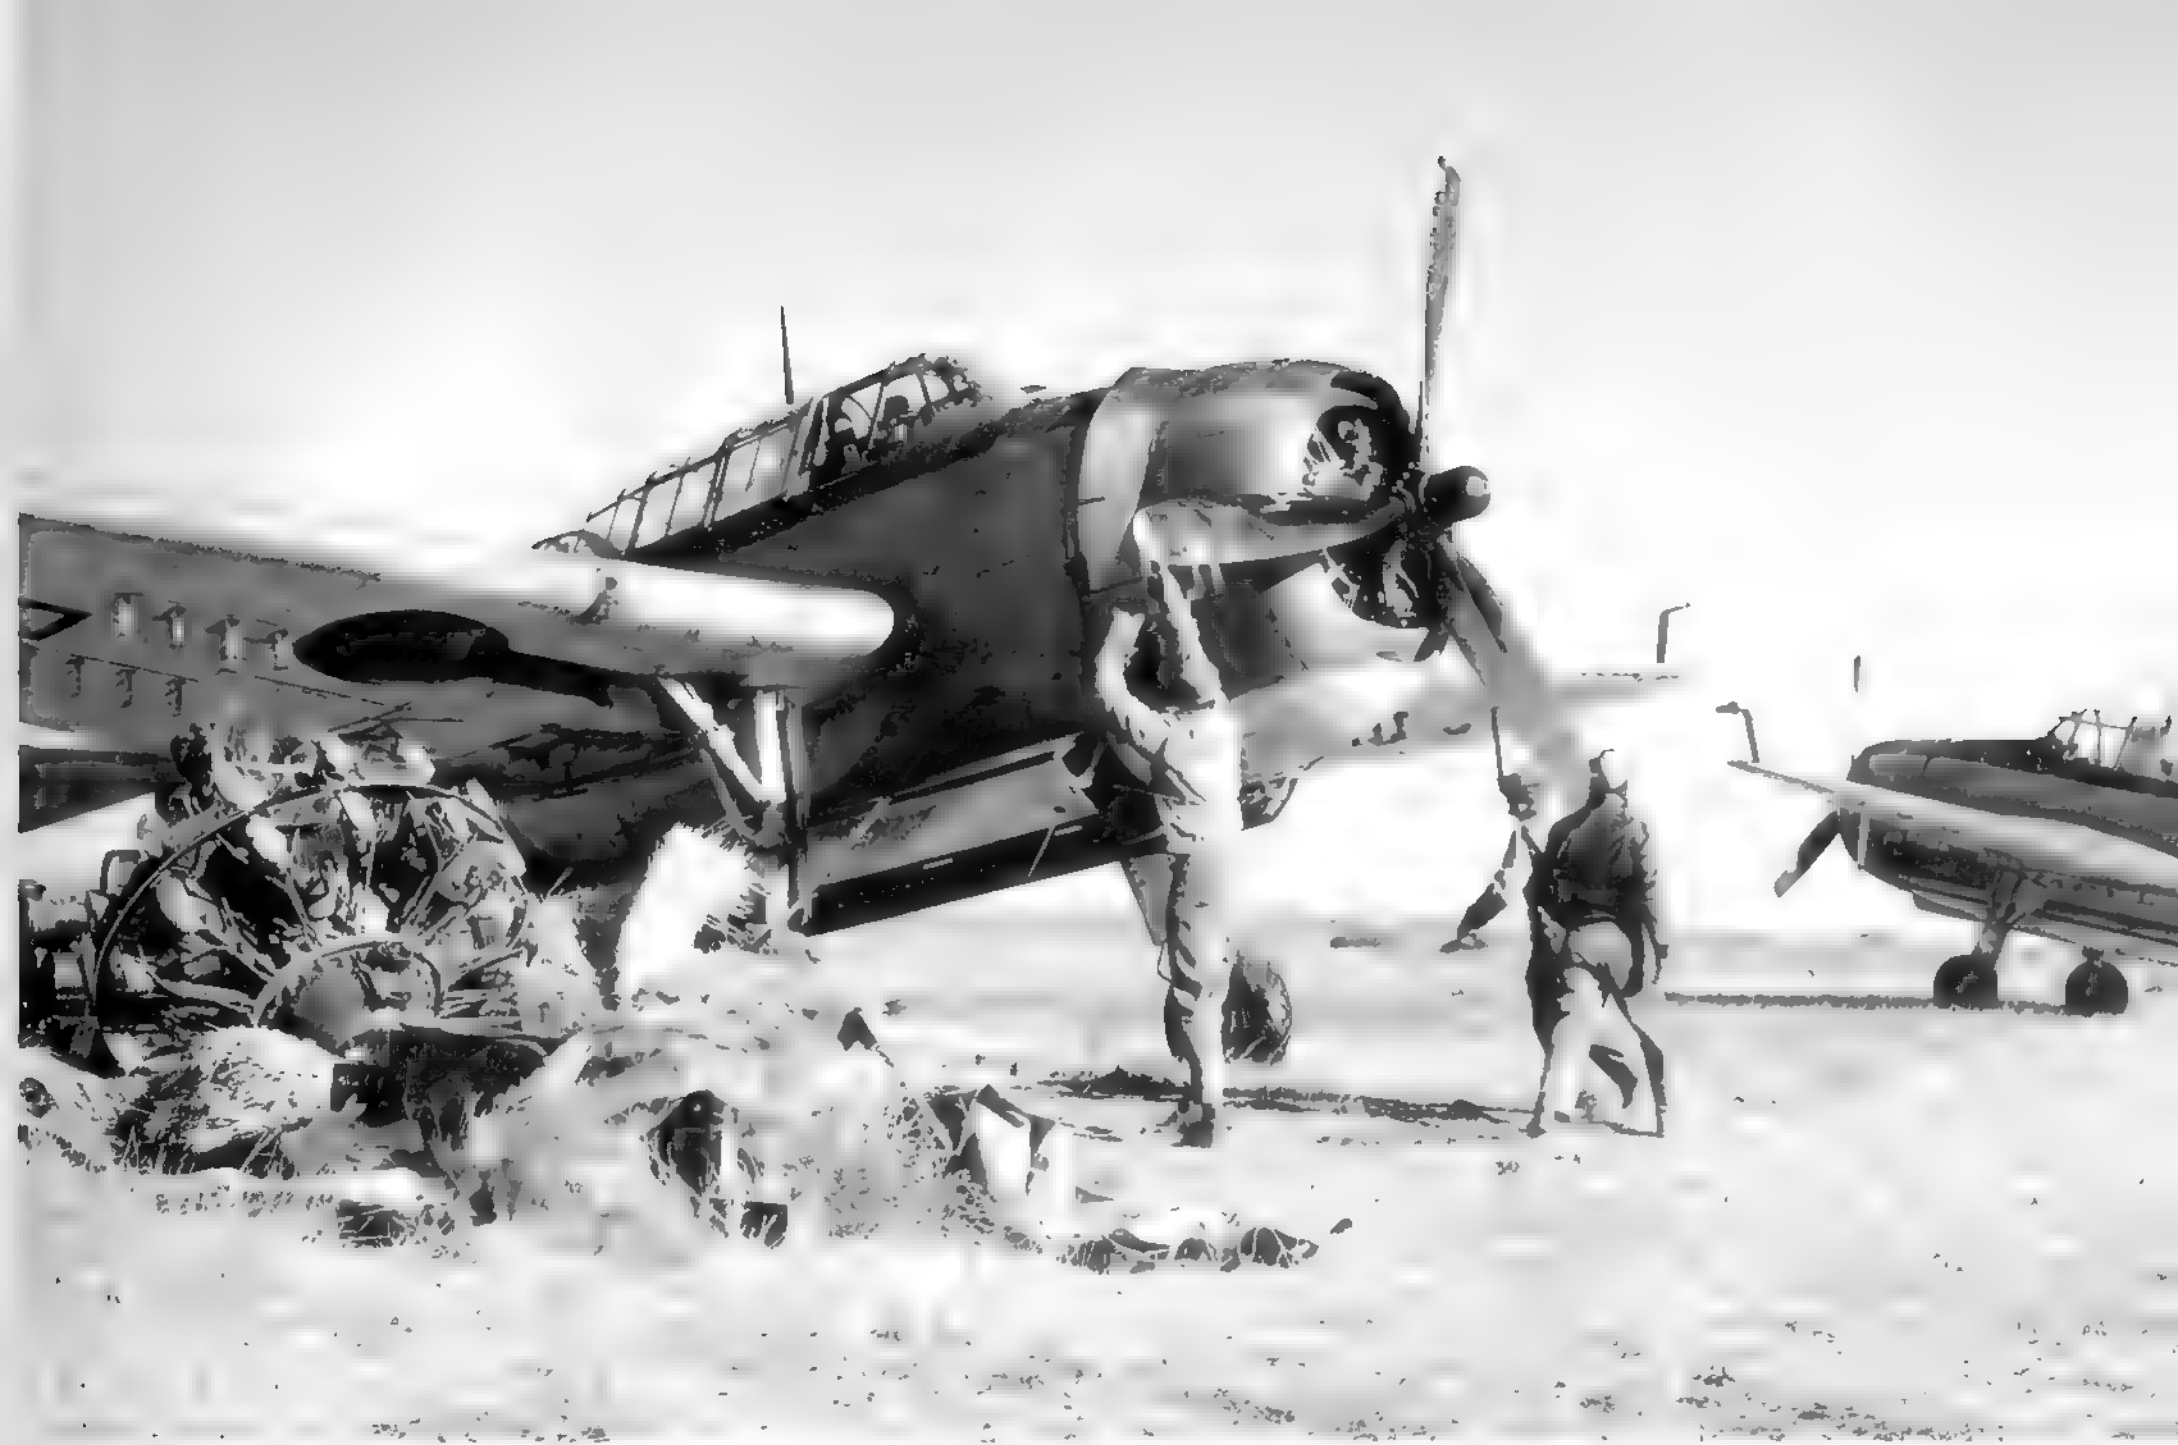
US Marine ground crews prepare a TBM-3 for a mission from Tientsin (now Tianjin), China in the fall of 1945. Ground crewmen pulled the propeller blades through at least four revolutions to move oil into the cylinders prior to starting the engine. A discarded R-2600 engine was placed in front of the aircraft's starboard wing. This Avenger was equipped

with four pairs of Mark 5 zero length rocket launch mounts under each wing. The bomb bay doors were open prior to being loaded with ordnance for the mission. US Marines were sent to China in October of 1945 to accept the surrender of Japanese forces there and to help keep order in chaotic post-war China. (Norman E. Taylor Collection)
